BUILDING CONDITION ASSESSMENT & CAPITAL EXPENDITURE FORECAST

MPCE Project No.: OCM 19-0188

August 21, 2019

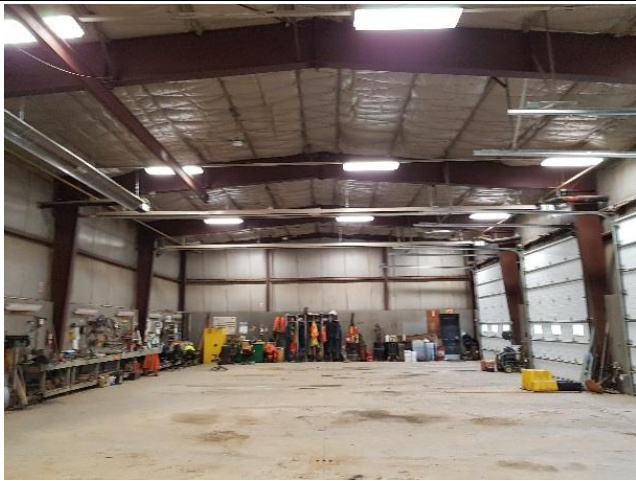
Photo 3a

From the components that are exposed and readily accessible the structure is deemed to be in good condition as no signs of excess differential settlement, deflection or cracking were observed. Typically, if kept adequately protected from the elements, the life expectancy of the structure will be equivalent to the life of the building. No major rehabilitation or reconstruction work is foreseen within the study period. **Refer to Photo 3a.**

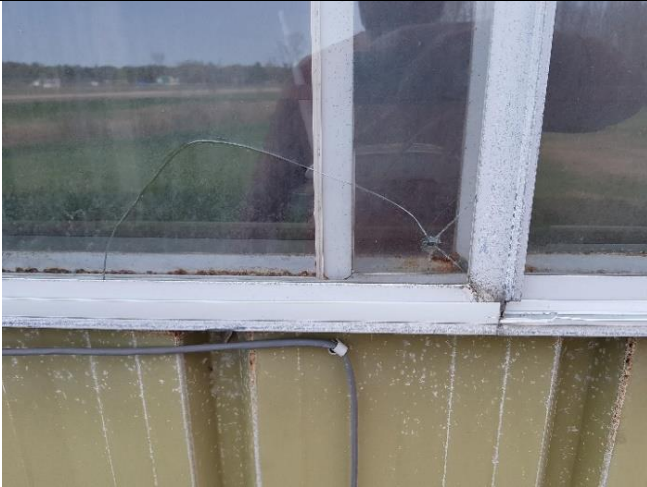
Photo 3c

Exterior windows include ten (10) horizontal slider single pane windows. The windows are deemed to be ageing but in satisfactory condition as all are operable with minor physical damage and discoloration observed. One horizontal slider had a crack in the glass. **Refer to Photo 3c.**

Typically, vinyl and metal framed assemblies have a life expectancy in the order of 20 to 40 years depending on the quality of material, workmanship and level of usage. It is in our opinion that the windows may require replacement within the study period as they are past their expected service life.

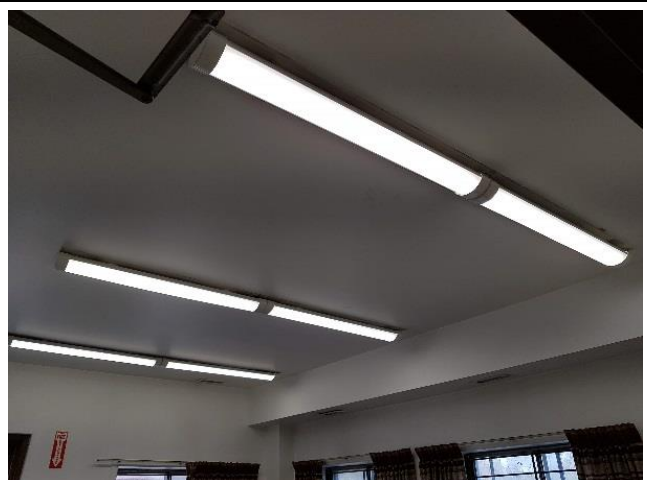
Photo 3f

Vaportite LED fixtures. All fixtures were replaced with LED in 2018. All observable electrical equipment and their associated wiring appear to be organized, labelled and in functional condition. There are no reported disruptions or outages to electrical services and as such electrical equipment is deemed to be in good condition. **Refer to Photo 3f.**

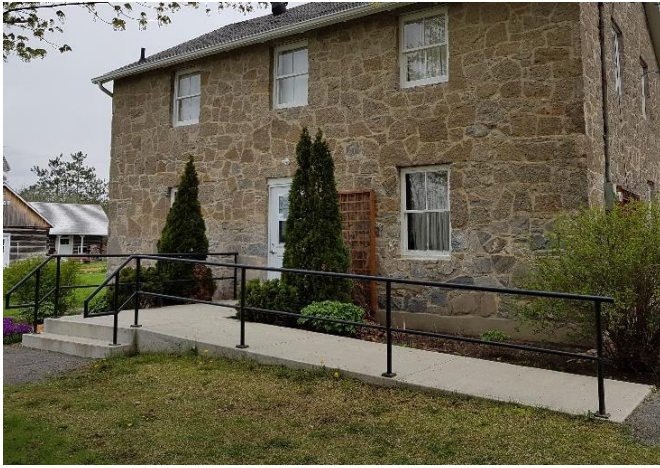
The building footprint of the Waba Cottage Museum is approximately 800 sq.ft. The property is shared with other buildings in the area which includes a shared common gravel driveway/parking and gravel walkways. The surrounding property features gardens, shrubs, grass and trees. There is also a small wooden arched bridge at the front of the property crossing a small wooden culvert. The back entrance features a concrete ramp/stairs and handrails. **Refer to Photo 9a and 9b.**

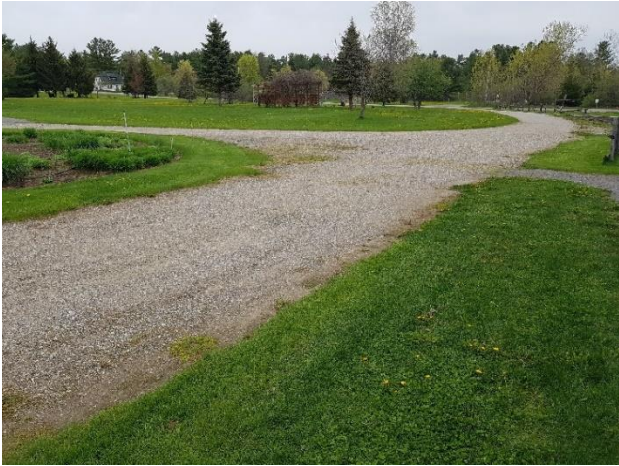
The building footprint of the McNab School Museum is approximately 560 sq.ft. The property is shared with other buildings in the area which includes a shared common gravel driveway/parking and gravel walkways. The surrounding property features concrete steps with landing to access the front door and a concrete ramp to access the building from the side door. The concrete steps/ramp connects to the gravel walkways to access the parking area and other museum buildings in the area. The remainder of the site consists of mostly grass, a small shared garden area, and small areas of mulch. **Refer to Photo 10a and 10b.**
