BUILDING CONDITION ASSESSMENT & CAPITAL EXPENDITURE FORECAST

MPCE Project No.: OCM 19-0188

August 21, 2019

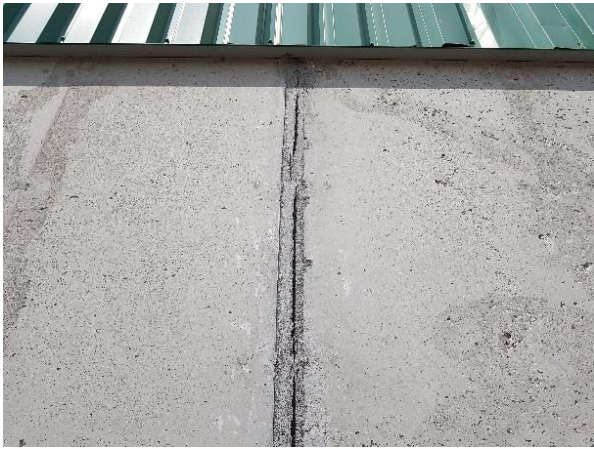
Photo 4a

The Salt/Sand Storage Shed is composed of three sections, namely the equipment storage shed and salt/sand storage shed that were original to construction (1994) and the newer salt/sand storage shed addition, constructed in 2002. Structural drawings for this addition were made available for review. The substructure is constructed of reinforced concrete foundation walls which protrude above grade by 12" at the equipment storage shed and then rise to 10'-0" in all other locations around the perimeter of the building. Within the bounds of the foundation wall is paved asphalt within the equipment storage shed and paved asphalt within both salt/sand storage sheds. Only minor cracking is observed in the various components of the substructure. There are no signs of corrosion within the rebar of the concrete walls which is a common type of distress for these types of structures. The expansion joints between original and new foundation wall construction are debonding and creating an unsealed joint for which precipitation can infiltrate through. **Refer to Photo 4a.**

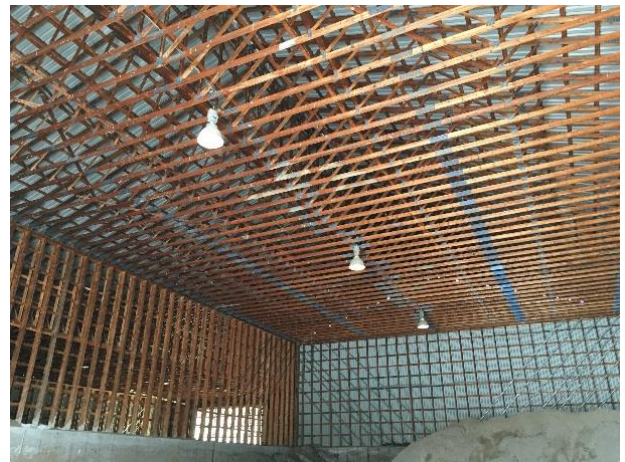
Photo 4b

Most of the structure is exposed and readily accessible and thus observations can easily be made throughout. The structure is deemed to be in good condition as no signs of excess differential settlement, deflection or cracking were observed. Typically, if kept adequately protected from the elements, the life expectancy of the structure will be equivalent to the life of the building. No major rehabilitation or reconstruction work is foreseen within the study period. **Refer to Photo 4b.**

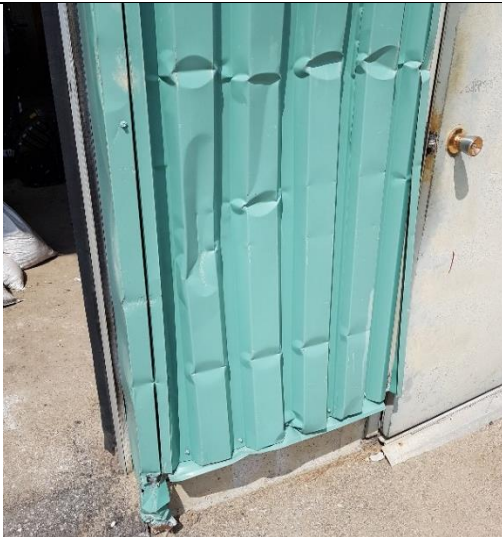
The life expectancy of metal siding is in the magnitude of 40 to 50 years therefore no major replacement is expected within this study period. The deficiencies and physical damage to the metal siding and flashing create opportunity for water to infiltrate through the building envelope and potentially damage underlying structure and should be rectified immediately. **Refer to Photo 4c and 4e.**

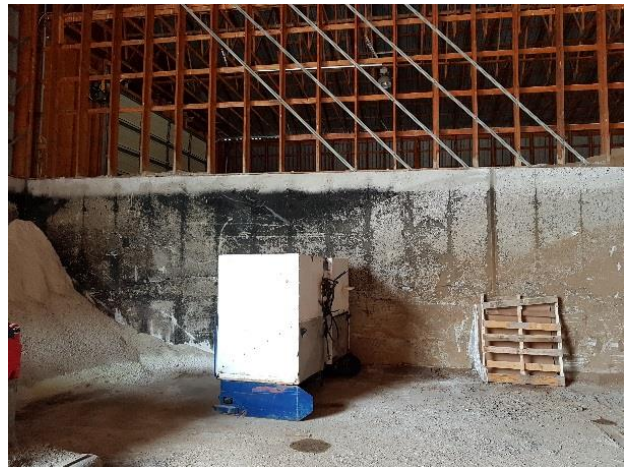
Photo 1d

nature of the salt and sand being stored within the building. It is recommended that this bituminous coating or salt retardant be reapplied over the entire inside face of the foundation wall within the next 3 years. **Refer to Photo 4d.** As an alternative to the bituminous coating, it is possible to use a modified polymer hydrophobic concrete sealant to retard the intrusion of chloride into the concrete.

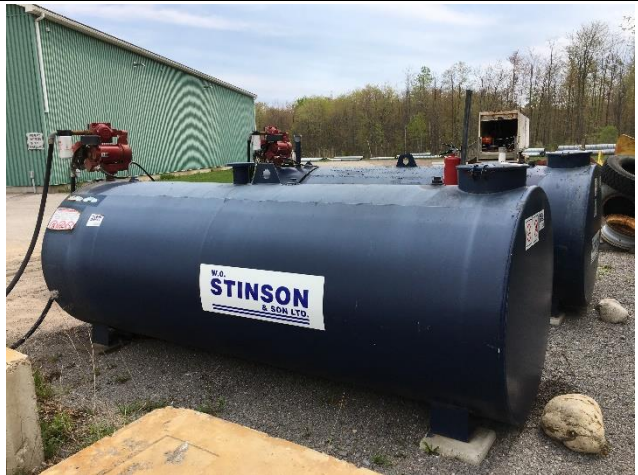
Photo 4f

Natural gas is received through “Enbridge” utilities. The utilities enter at the south east corner of the building. This is where the meter is located on the exterior of the building. From this location the gas is distributed to two (2) ceiling hung gas radiant tube heaters, both located within the equipment storage shed. In addition, there are two above ground storage tanks (ASTs) located to the south east of the building for refueling vehicles/equipment. Based on there current conditions no immediate replacement of equipment is required, however, they have been included as a capital expense based solely on the life expectancies of industrial mechanical equipment of 20 years for above ground storage tanks. According to the Township, the above ground fuel storage tanks are rented. **Refer to Photo 4f.**

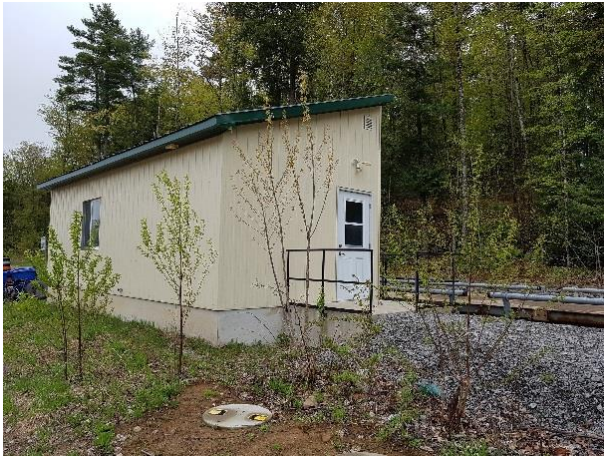
Photo 6a

The building footprint of the Landfill Scale Office is approximately 336 sq.ft. The surrounding property features a vehicle scale at the side of the building and graded granular driveways and granular parking area. There are no eaves and the rainwater drains from the mono-pitch roof onto the grass. The grading surrounding the building can be improved to ensure water is diverted away from the building. The entranceway consists of concrete stairs with landings at each of the exterior doors. The walkway to the concrete stairs is gravel. The remainder of the site consists of grass and small trees. **Refer to Photo 6a.**

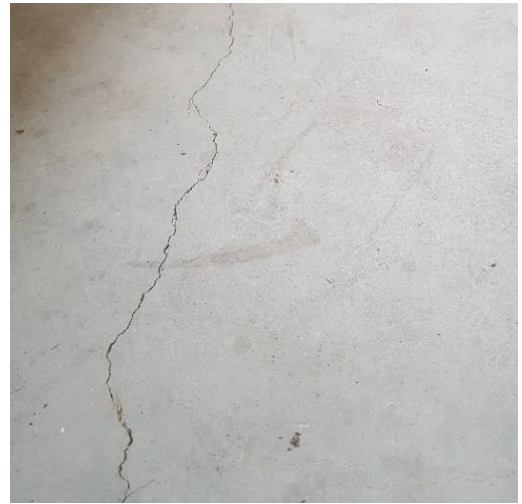
Photo 6b

The foundation appears to be in good condition. There is no visible cracking of the foundation and no signs of differential settlement/heaving. If kept adequately protected from the elements, the life expectancy of concrete foundation is equivalent to life of the structure. The concrete interior slab had signs of minor cracking throughout the building. Cracking of the slab is common and is likely due to plastic shrinkage of the concrete. This may be due to lack of saw cuts in the slab which are used to control the location of concrete cracking. Nonetheless, the cracking of the exposed slab is not a concern and no repairs or alterations are expected within this study period. **Refer to Photo 6b.**

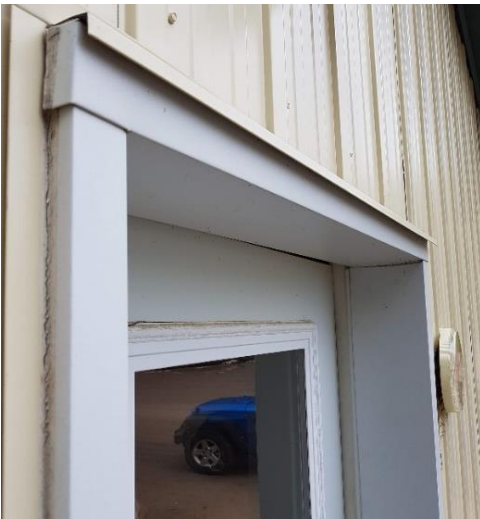
Photo 6c

The building has two (2) single man vinyl doors with a hung window insert. The doors and all its components appear in satisfactory condition and no damages were observed. The life expectancy of vinyl doors is approximately 20 years. It is expected that the doors will need to be replaced within this study period, priority "recommended long term". It is recommended to seal and caulk the exterior windows and doors to prolong their life and prevent any water infiltration issues. **Refer to Photo 6c.**

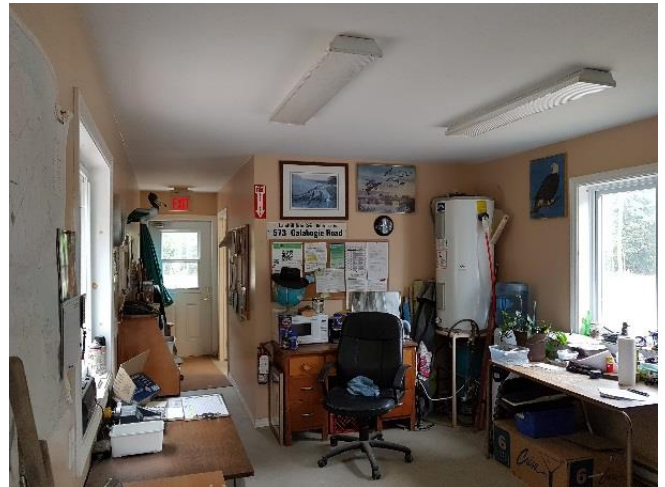
Photo 6d

The interior building's finish is a white painted drywall on the ceiling and a beige painted drywall along the walls. No issues were observed along the building's interior finish. Any repainting of the drywall is considered a maintenance item and is not included in the scope of this study. **Refer to Photo 6d.**

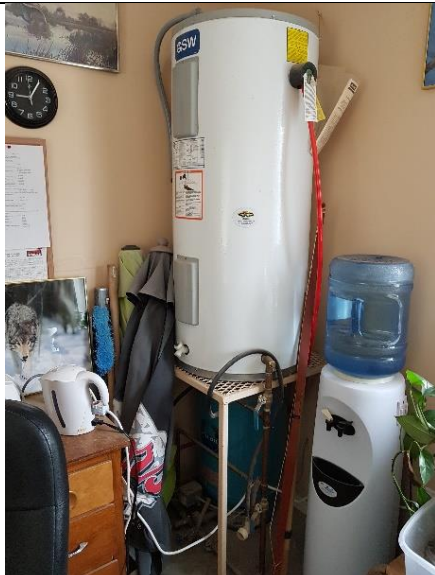
Photo 6e

There is one (1) electric water heater and one (1) well water storage tank. There is also one (1) Ouellet radiant heater in the common room. Based on their current conditions, no immediate replacement of equipment is required; however, they have been included as a capital expense based solely on the life expectancies of mechanical equipment, 15-20 years for electric hot water and well storage tanks. **Refer to Photo 6e.**

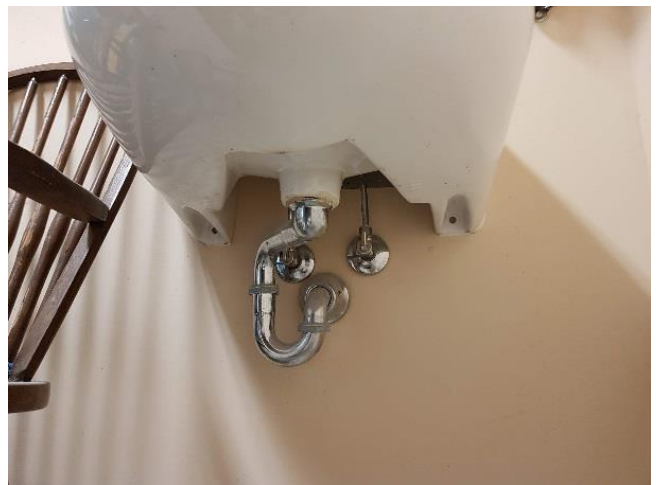
Photo 2f

Water is received from the on site drilled well where it is then distributed by copper piping and stainless-steel fittings. There is a washroom located within the building with one (1) bathroom sink, one (1) toilet, and one (1) shower. Sanitary waste is disposed of through an on-site septic system. During the site visit, plumbing fixtures were tested and found to be functional and in good condition. **Refer to Photo 6f.**

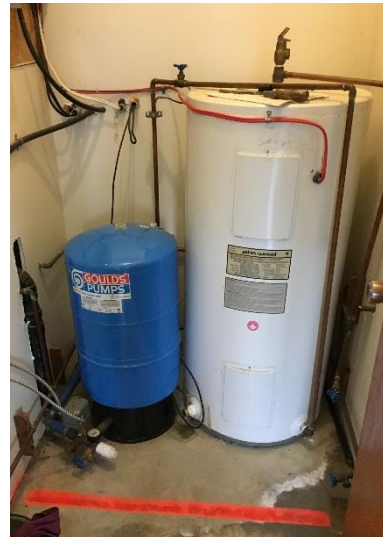
Photo 13f

There are no natural gas utilities seen in the facility. There is one (1) hot water tank, one (1) water storage tank. Capital expense based solely on the life expectancies of industrial mechanical equipment, ranging from 15 to 25 years, is also listed below. Based on the current age of the hot water tank and pressure tank, they are expected to be replaced within the next 3-5 years. **Refer to Photo 13f.**

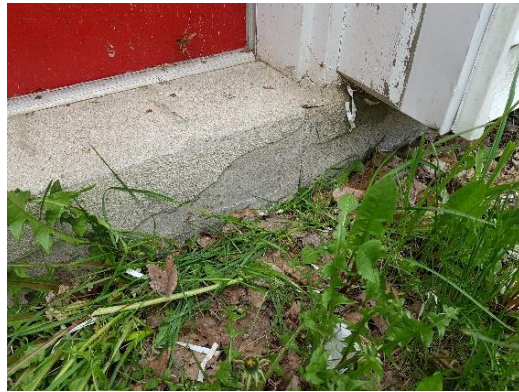
Photo 14b

The parging on the protruded section of the foundation showed signs of minor cracks. These cracks were mostly observed at the side entrance exterior door of the garage bay. The cracks on the foundation parging should be repaired to ensure the foundation wall continues performing satisfactorily. These repairs should be carried out within this study period. **Refer to Photo 14b.**

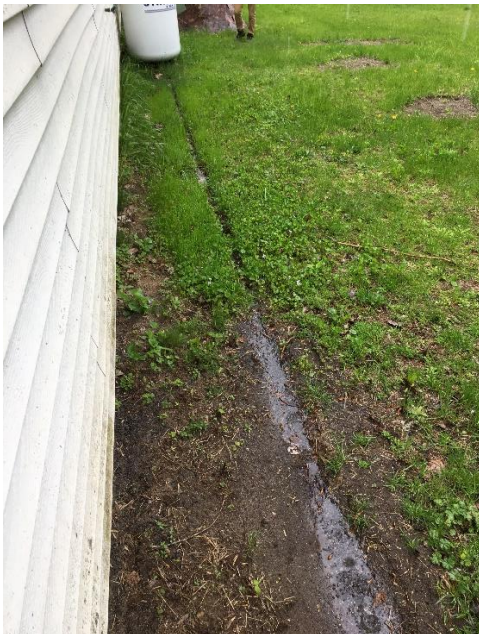
Photo 14c

The roof is a gable and valley roof, finished with asphalt shingles. The roof is sloped at about 4 to 12. Asphalt shingles have a life span of 20 to 30 years. Hence, the replacement of the asphalt shingles will not be in this study period. Documents provided show the roof shingles were replaced in 2018. One drainage eave was observed at the front entrance of the office building. It did not have an accompanying downspout to ensure that the water is discharged away from the building. The remaining perimeter of the roof had no eavestroughs or downspouts. Both should be installed to avoid moisture damage to the exterior finishes and foundation of the building. **Refer to Photo 14c.**

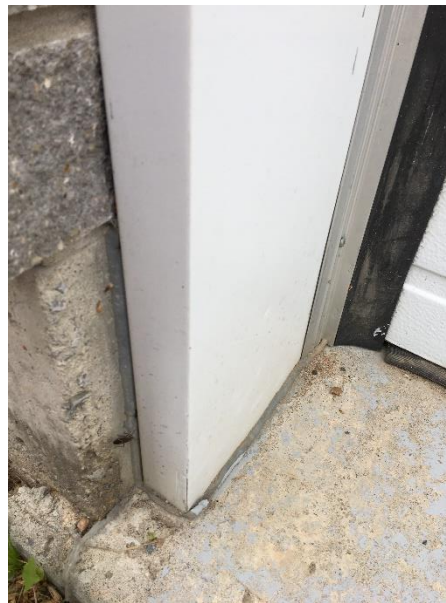
Photo 16d

The two (3) 12'-0" x 14'-0" overhead garage doors are displaying signs of ageing. Typically, overhead doors last 15-30 years. It is assumed these overhead doors are original to the building and therefore it is expected they will need to be replaced within the study period. It is recommended to extend the life of the door jambs and garage door components by caulking and sealing around the doors and flashing. **See photo 16d.**

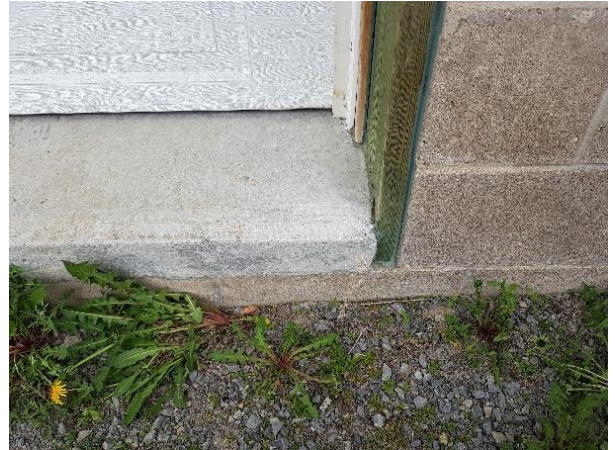
Photo 17b

Exterior doors include four (4) man doors and one (1) 9'-0" x 7'-0" overhead garage door. The 9' x 7' overhead garage door has a typical life span of 15 to 30 years. It is assumed the overhead door is original to the building and therefore it is expected to be replaced within this study period. The caulking around all windows and doors appears to be original to the construction. The caulking is ageing as we observed discoloration, debonding, and loss in elasticity. It is recommended that caulking/sealant be replaced within the next 5 years. **Refer to Photo 17b.**

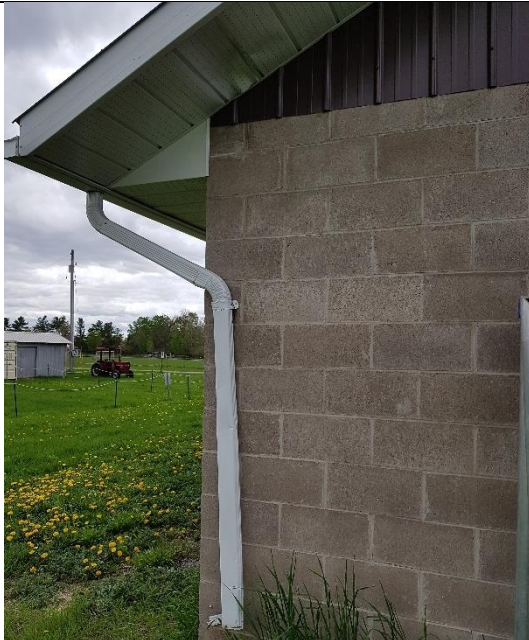
Photo 17c

The roof is finished with corrugated metal sheet panels complete with appropriate flashing and fascia. The gable end of the roof is sealed off with similar metal sheet with a vent at the centre area of each gable end. The slope of the roof is about 8 to 12. The roof was in good working condition at the time of our site visit. Eavestroughs collect water on both sides of the roof and then direct it to downspouts located at each rear corner of the building. The downspouts require reconnection of extensions to ensure water is discharged out and away from the building. **Refer to Photo 17c.**

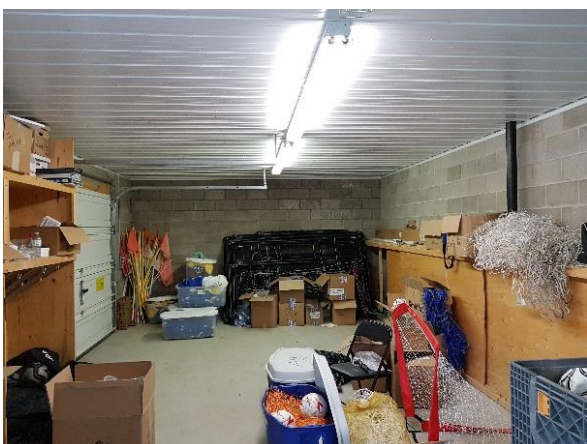
Photo 17e

The interior of the building is primarily an unfinished masonry block wall. The floor is an unfinished concrete slab-on-grade. The ceiling of the building is finished with corrugated sheet metal. **Refer to Photo 17e.**

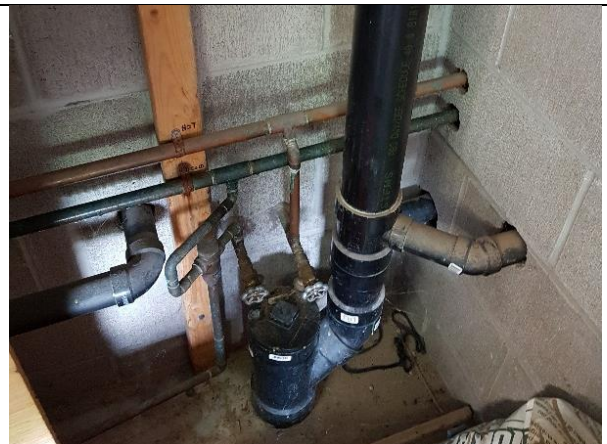
Photo 17f

Water is received from an on-site drilled well and supplied to the building, distributed by copper piping and stainless-steel fittings. **Refer to Photo 17f**. There are male and a female washroom within the structure that open to the exterior at the opposite side of the front entrance. The following is an inventory of the fixtures found throughout the building: Two (2) kitchen sinks, four (4) bathroom sinks, four (4) stalls, four (4) toilets, and one (1) urinal. Sanitary waste is disposed of through an on-site septic system. During the site visit, plumbing fixtures were tested and found to be functional and in good condition.
